Tennessee Building and Moisture Analysts

Stucco Inspection and Report

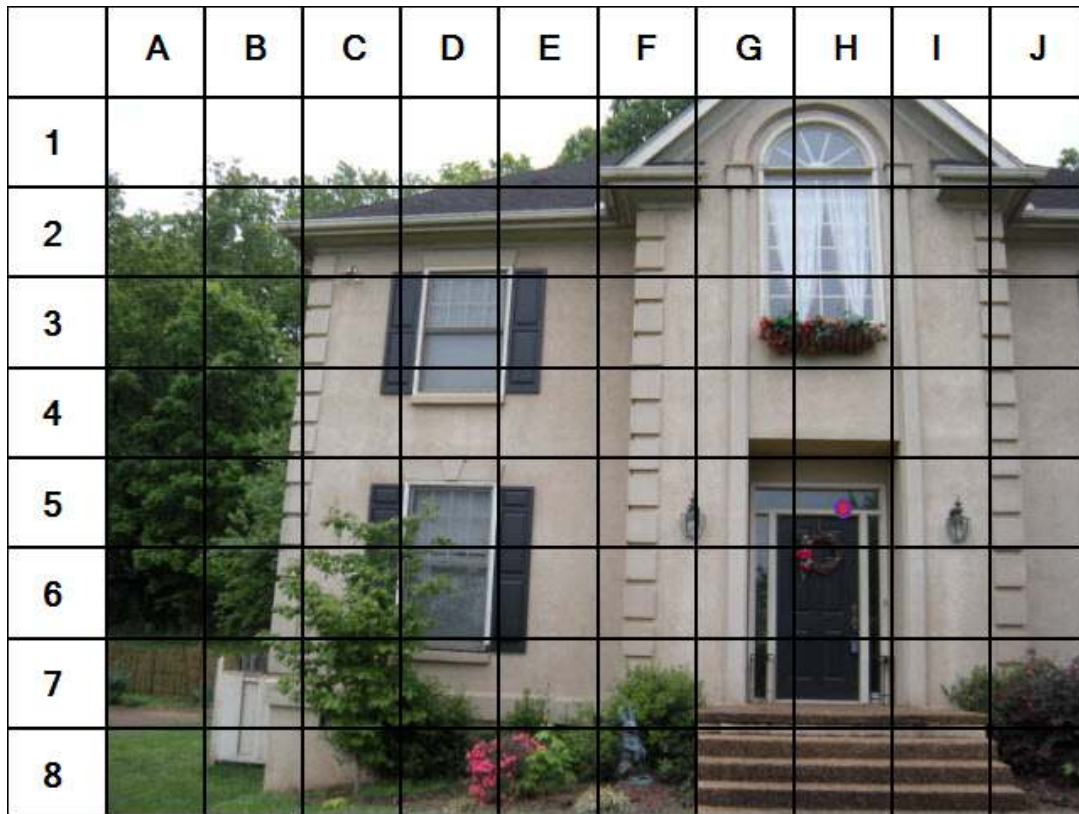
Front Elevation

Grid Location	Item Description	Moisture Readings	Substrate Condition	Observations	Chapter Reference
C4	Windows	15	Firm	Area where moisture reading was obtained.	
D4	Windows	14	Firm	Area where moisture reading was obtained.	
C7	Windows	21	Soft	Elevated moisture reading at window	
D7	Windows	28	Soft	Elevated moisture reading at window	
G3	Windows	20	Soft	Elevated moisture reading at window	
H3	Windows	19	Firm	Elevated moisture reading at window	
G8	Doors	11	Firm	Door construction and thresholds need to be caulked.	
I8	Doors	12	Firm

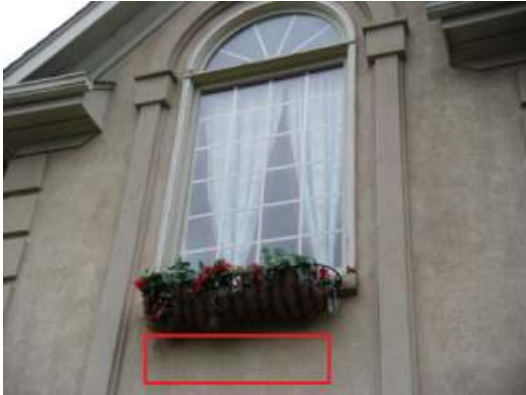
Elevated reading

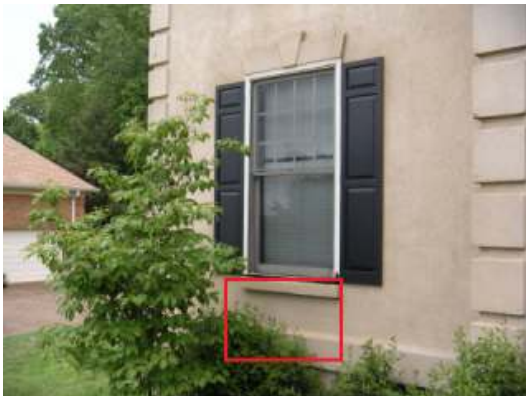
Elevated reading. Damage around window

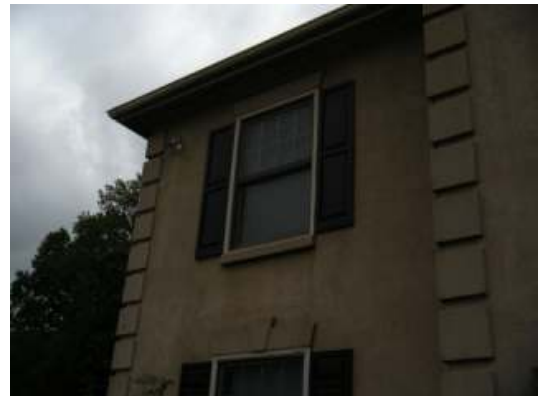
Normal reading

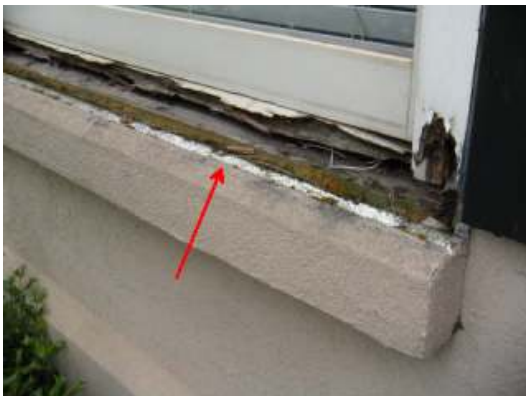
Window rot

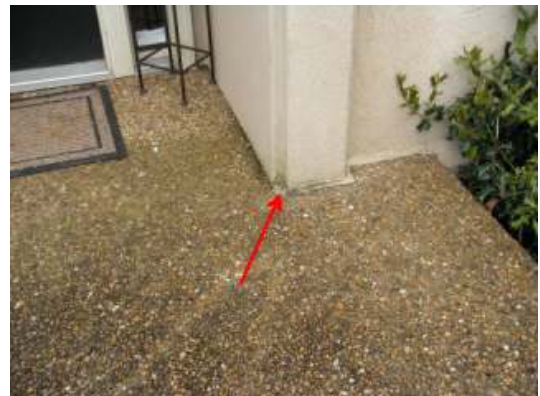
Needs termite joint

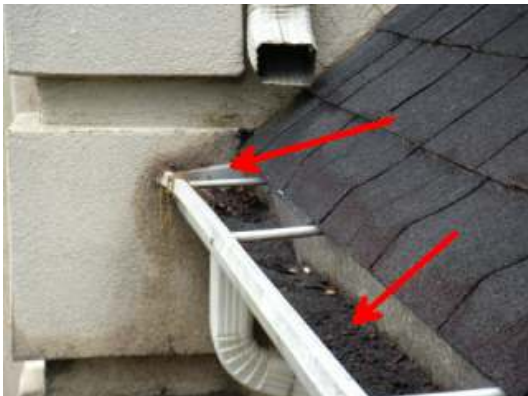
Missing kick out. Gutter full

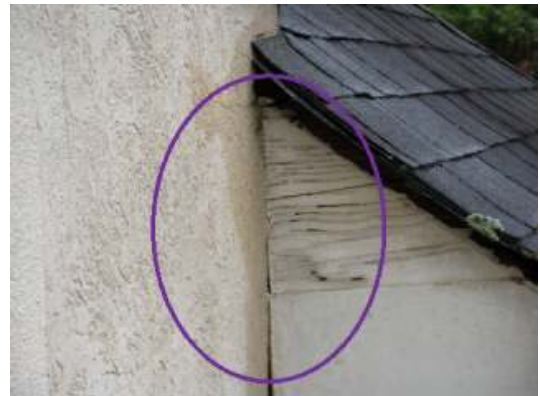
Trim damage

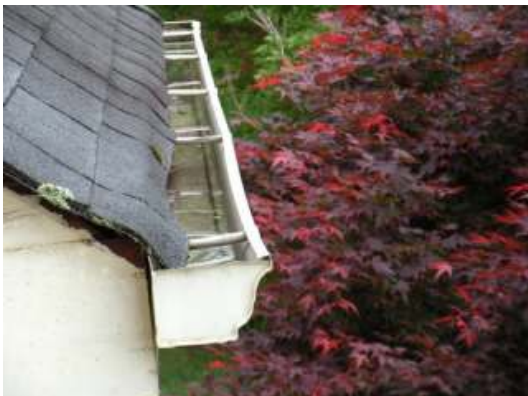
Full gutter/blocked

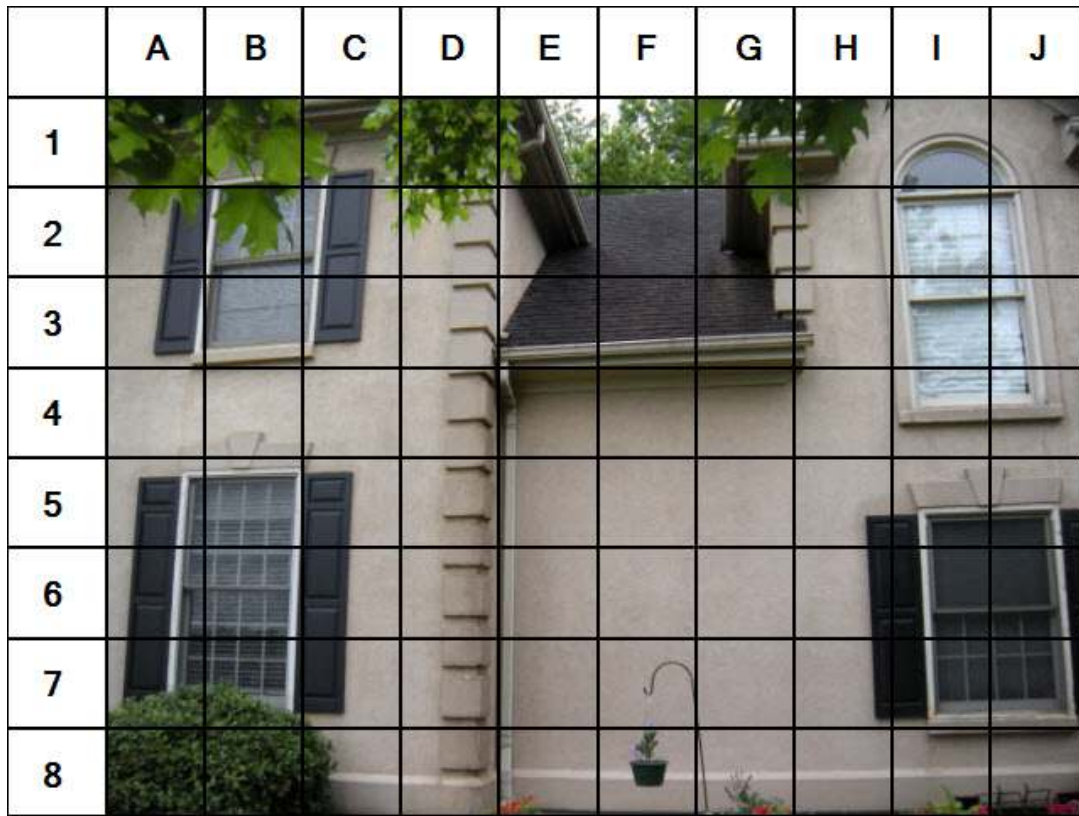
Front Center Elevation

Grid Location	Item Description	Moisture Readings	Substrate Condition	Observations	Chapter Reference
A3	Windows	12	Firm	Area where moisture reading was obtained.	
B3	Windows	14	Firm	Area where moisture reading was obtained.	
A7	Windows	18	Soft	Elevated moisture reading at window	
B7	Windows	22	Soft	Elevated moisture reading at window	
E4	Kickout	28	Soft	Elevated moisture reading below kickout.	
E6	Kickout	23	Soft	Elevated moisture reading below kickout.	
I4	Windows	19	Firm	Elevated moisture reading at window	
J4	Windows	20	Firm	Elevated moisture reading at window	
I8	Windows	23	Soft	Elevated moisture reading at window	
J8	Windows	25	Soft	Elevated moisture reading at window

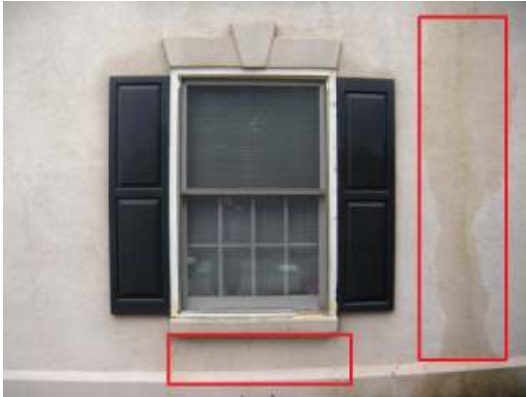
Elevated readings

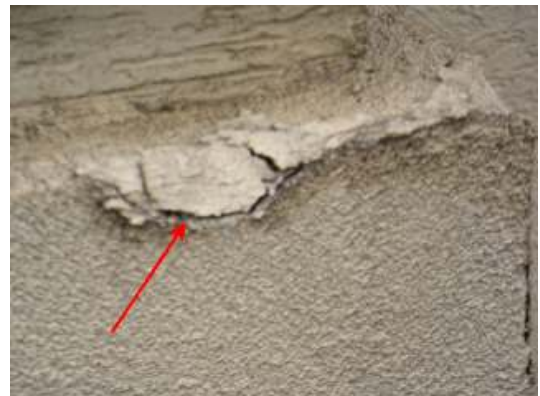
Impact damage

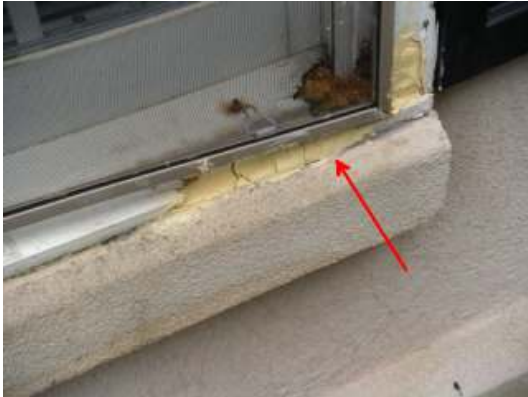
Sill rot

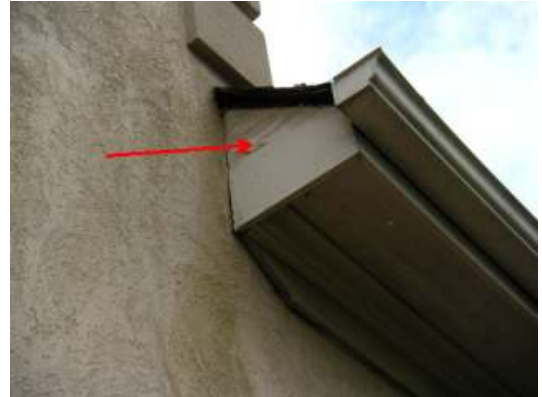
Fascia rot

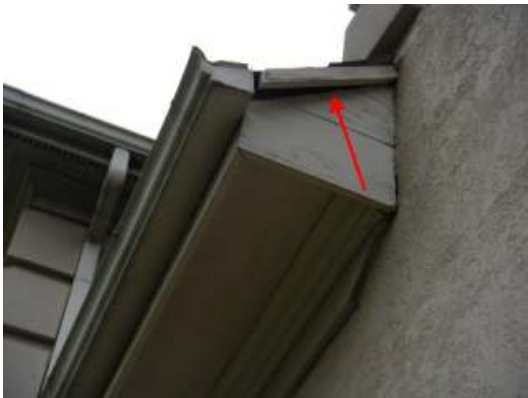
Trim damage

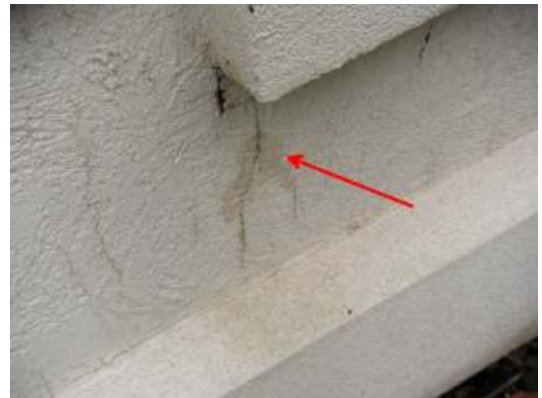
Moisture evidence below window

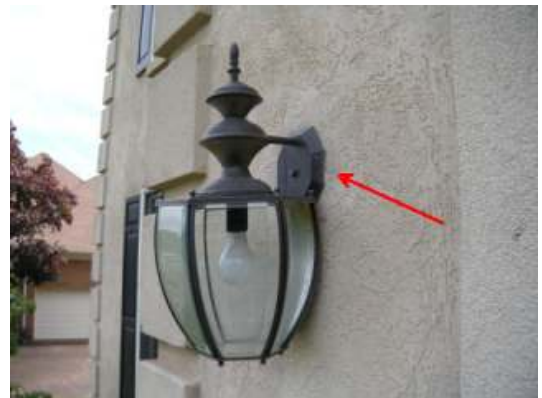
Missing caulk

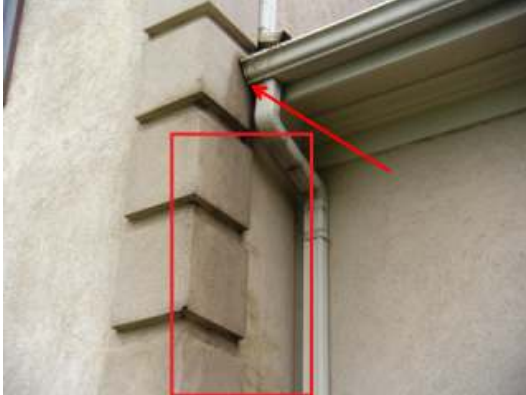
Missing kick out. Damage below kick out

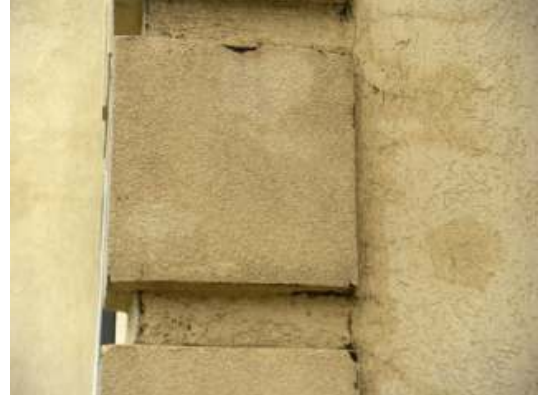
Damaged quions

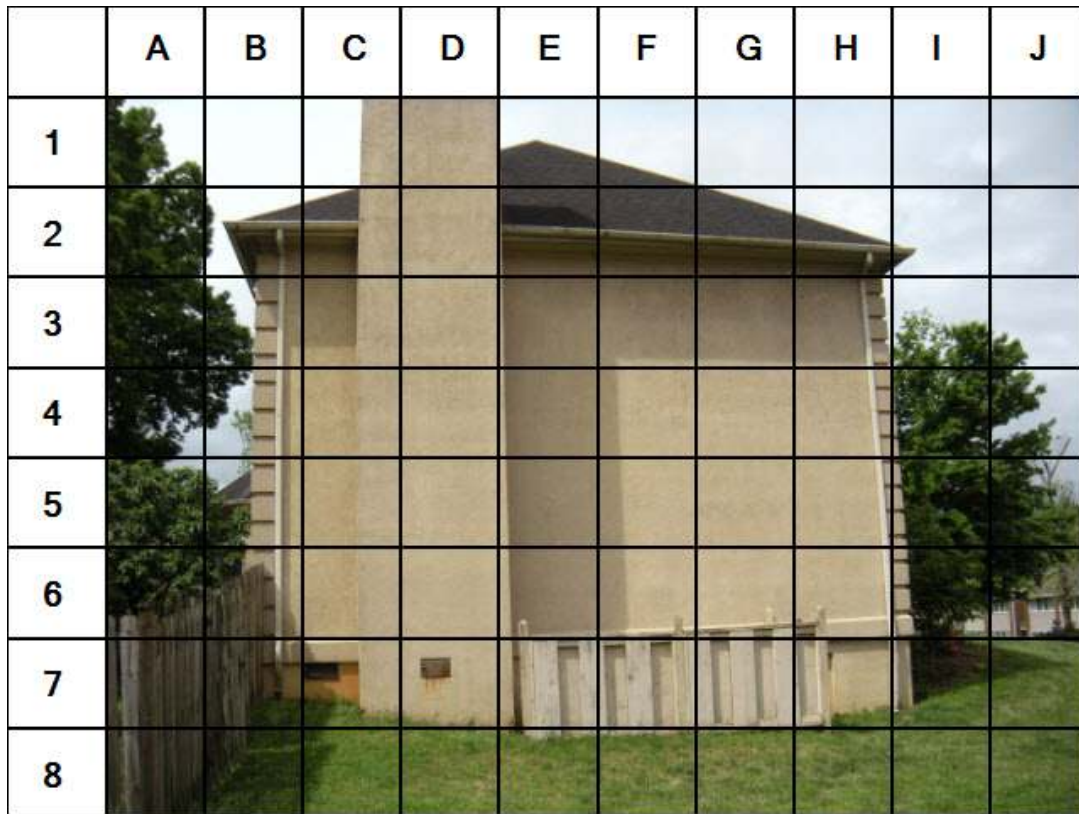
Back Elevation

Grid Location	Item Description	Moisture Readings	Substrate Condition	Observations	Chapter Reference
C2	Kickout	21	Firm	Elevated moisture reading below kickout.	
C6	Kickout	19	Firm	Elevated moisture reading below kickout.	
E2	Kickout	20	Firm	Elevated moisture reading below kickout.	
E6	Kickout	23	Firm	Elevated moisture reading below kickout.

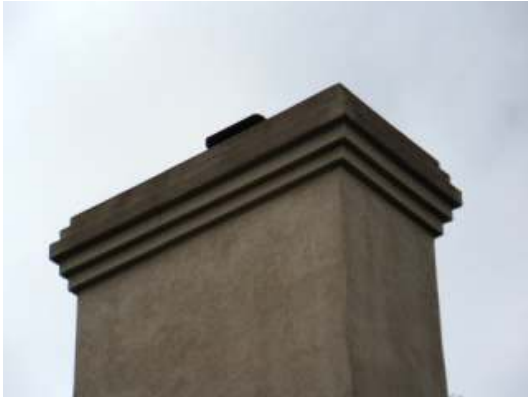
Missing chase cap

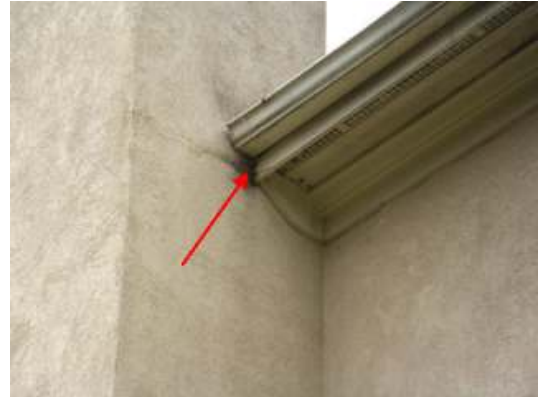
Missing kick out

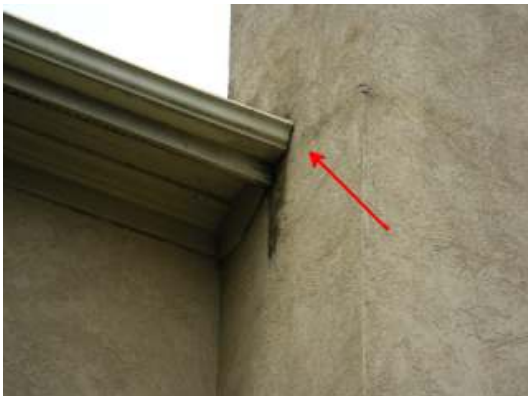
Missing kick out

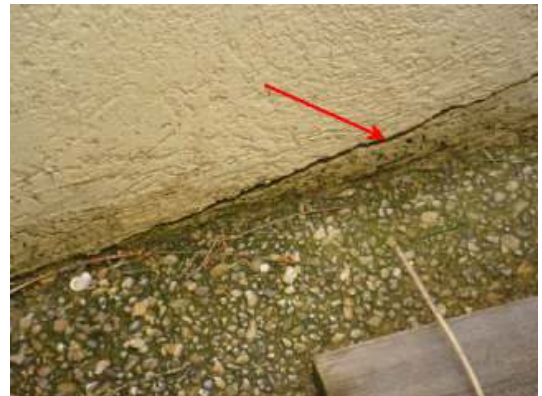
Crack in stucco

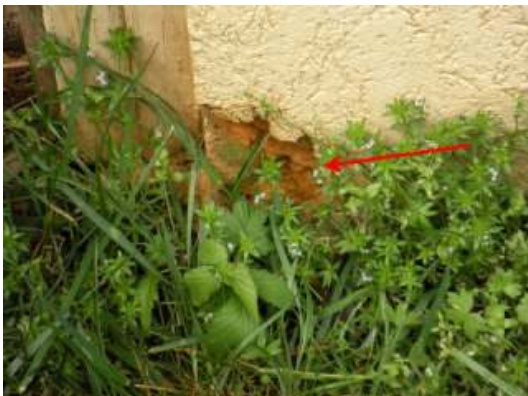
Stucco damage. Stucco below grade

Areas to the left and rear need modification to raise the stucco above ground level

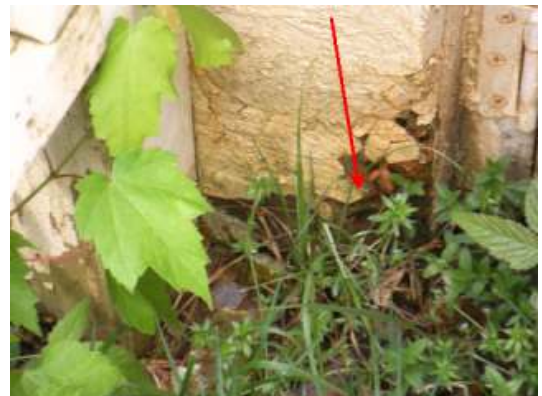
Stucco damage

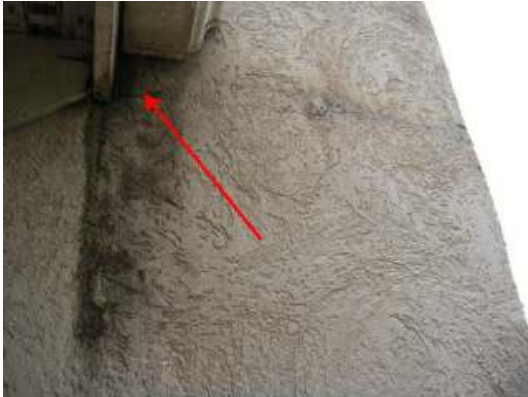
Moisture due to missing kick out

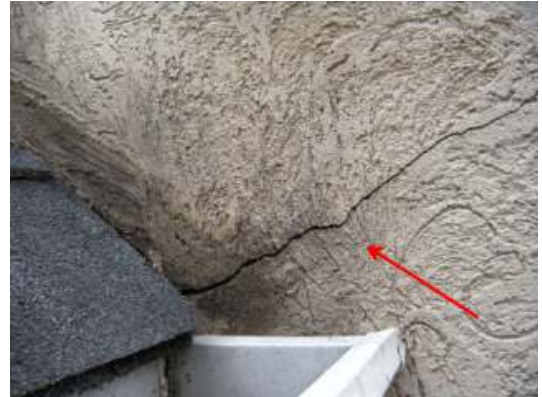
Missing kick out. Crack in stucco due to moisture

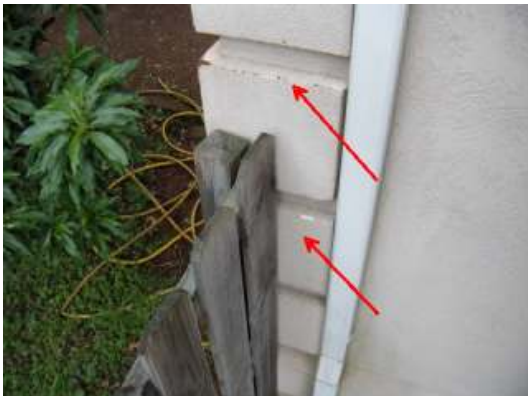
Damaged quoins

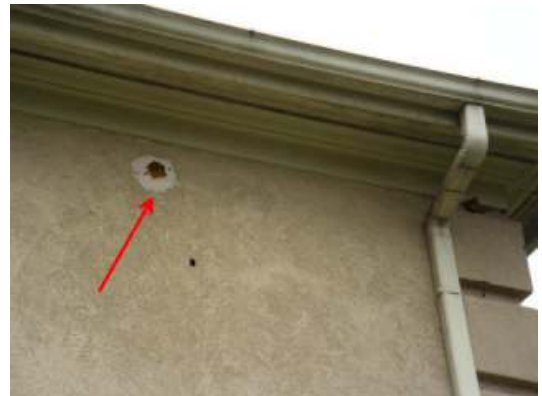
Bird holes

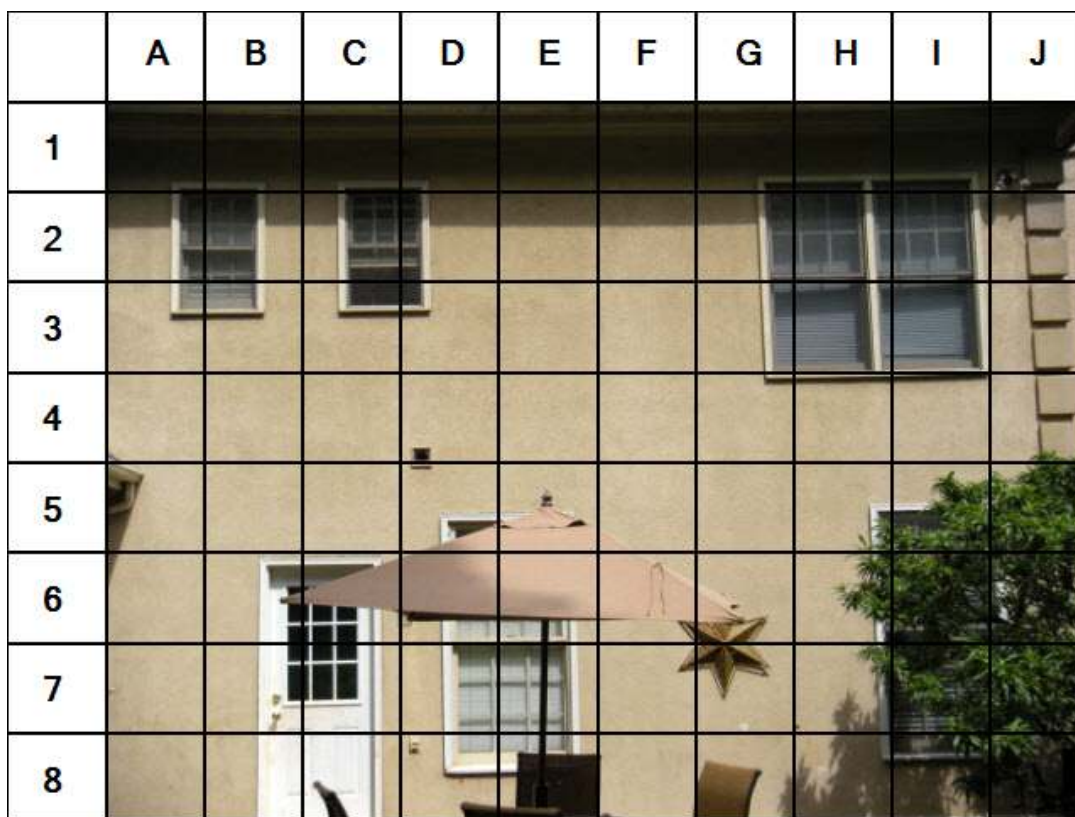
Left Elevation

Grid Location	Item Description	Moisture Readings	Substrate Condition	Observations	Chapter Reference
A3	Windows	11	Firm	Area where moisture reading was obtained.	
B3	Windows	10	Firm	Area where moisture reading was obtained.	
C3	Windows	14	Firm	Area where moisture reading was obtained.	
D3	Windows	12	Firm	Area where moisture reading was obtained.	
G4	Windows	13	Firm	Area where moisture reading was obtained.	
J4	Windows	9	Firm	Area where moisture reading was obtained.	
D8	Windows	15	Firm	Area where moisture reading was obtained.	
E8	Windows	14	Firm	Area where moisture reading was obtained.	
I8	Windows	12	Firm	Area where moisture reading was obtained.	
J8	Windows	16	Firm	Elevated moisture reading at window

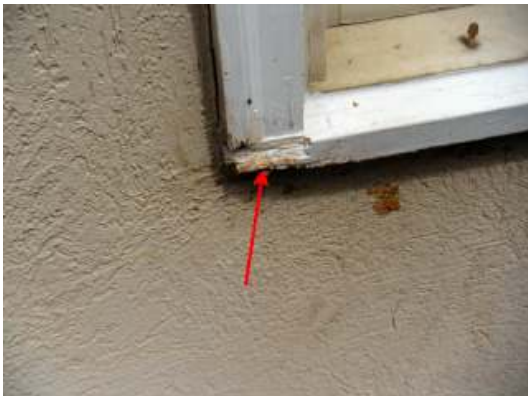
Damaged sill

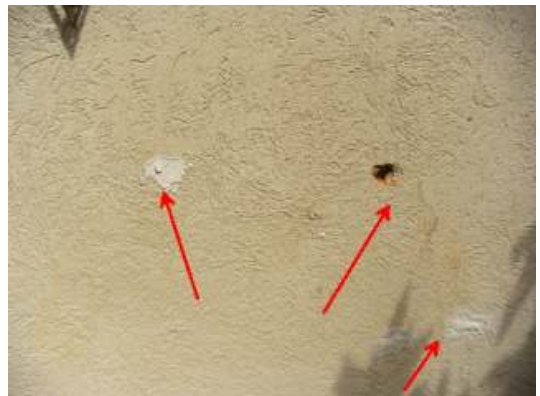
Impact damage

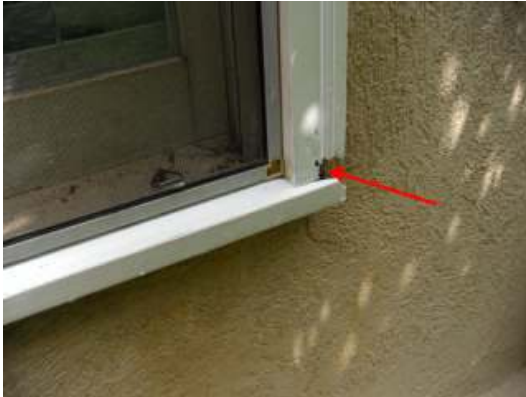
Brick mold damage

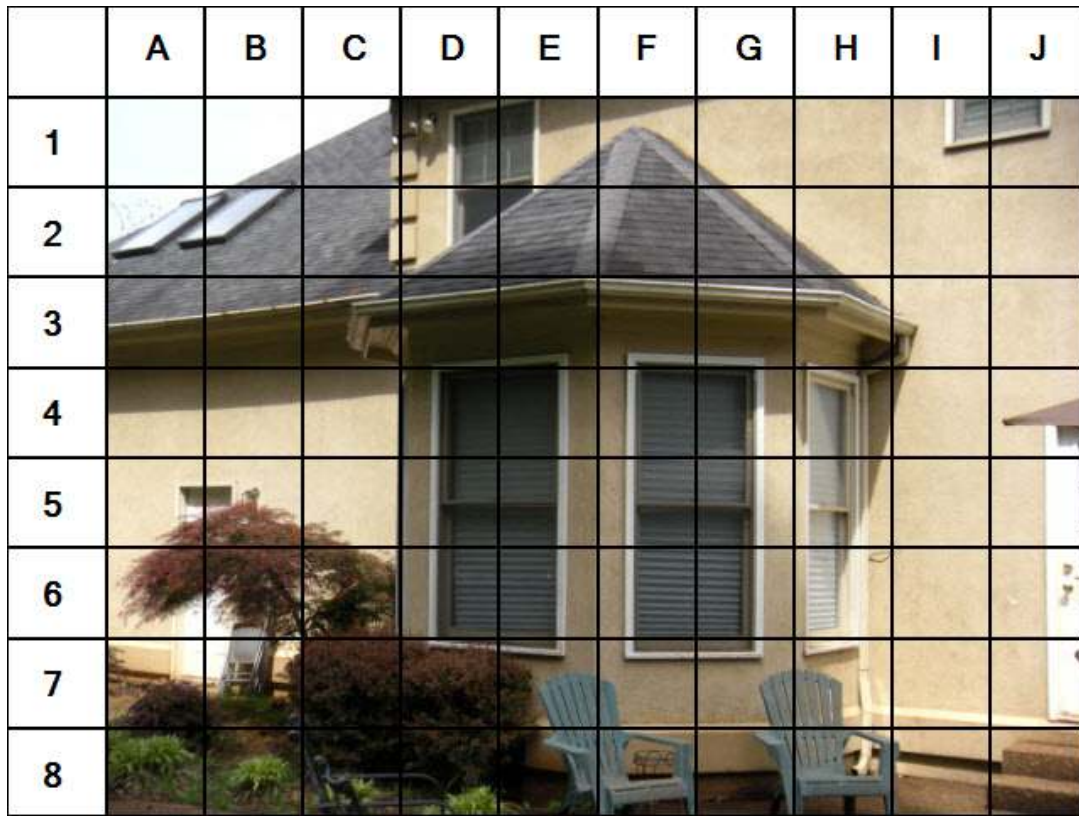
Left Side Right Elevation

Grid Location	Item Description	Moisture Readings	Substrate Condition	Observations	Chapter Reference
I4	Kickout	12	Firm	Area where moisture reading was obtained.	
I6	Kickout	13	Firm	Area where moisture reading was obtained.	
H7	Windows	10	Firm	Area where moisture reading was obtained.	
H7	Windows	13	Firm	Area where moisture reading was obtained.	
F7	Windows	11	Firm	Area where moisture reading was obtained.	
G7	Windows	12	Firm	Area where moisture reading was obtained.	
D7	Windows	14	Firm	Area where moisture reading was obtained.	
E7	Windows	15	Firm	Area where moisture reading was obtained.

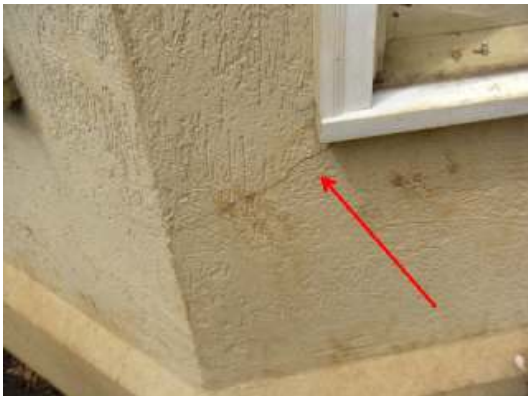
Crack in stucco

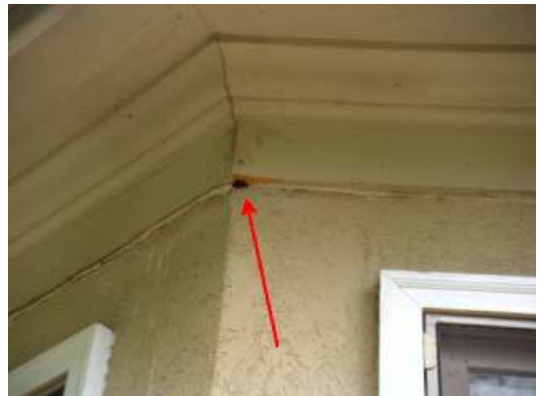
Hole in stucco

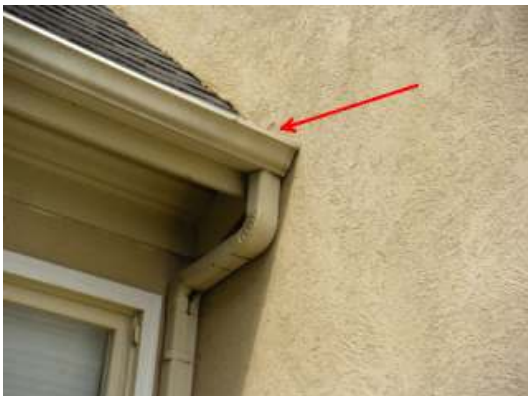
Missing kick out

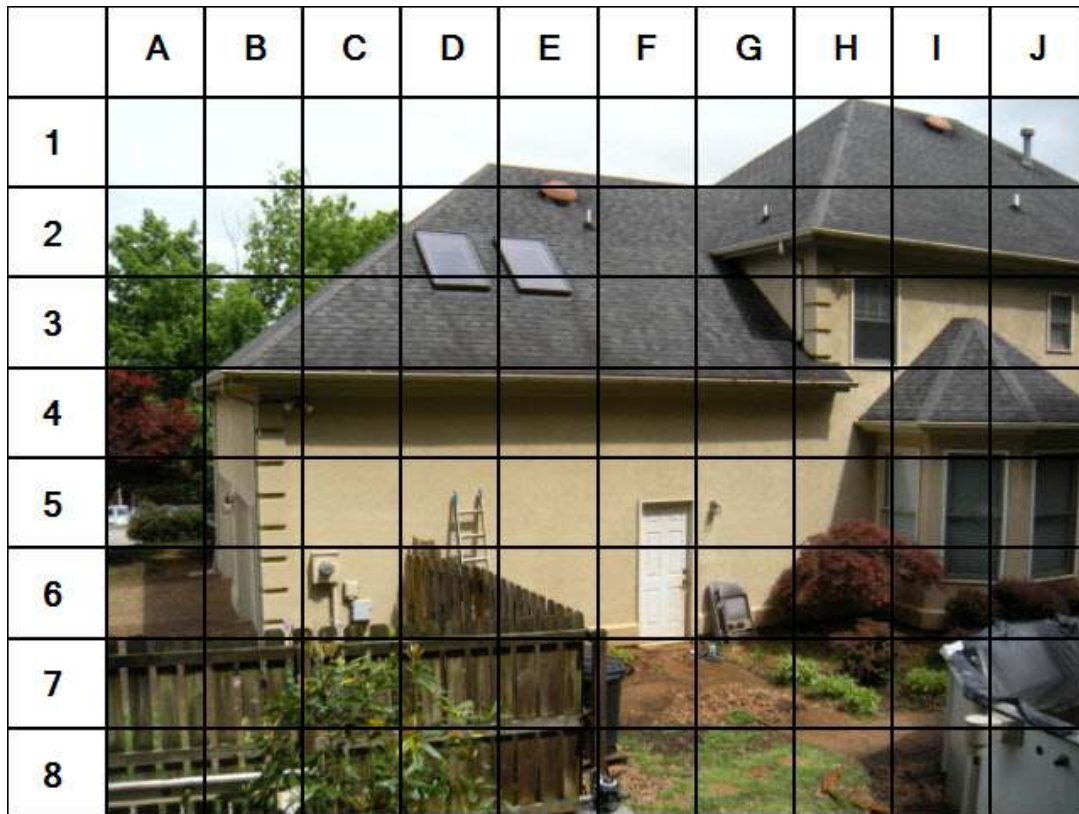
Garage Elevation

Grid Location	Item Description	Moisture Readings	Substrate Condition	Observations	Chapter Reference
H5	Kickout	12	Firm	Area where moisture reading was obtained.	
H6	Kickout	11	Firm	Area where moisture reading was obtained.	
H3	Windows	10	Firm	Area where moisture reading was obtained.	
I3	Windows	13	Firm	Area where moisture reading was obtained.	
H7	Windows	21	Soft	Elevated moisture reading at window	
I7	Windows	26	Soft	Elevated moisture reading at window	
I7	Windows	12	Firm	Area where moisture reading was obtained.	
J7	Windows	14	Firm	Area where moisture reading was obtained.

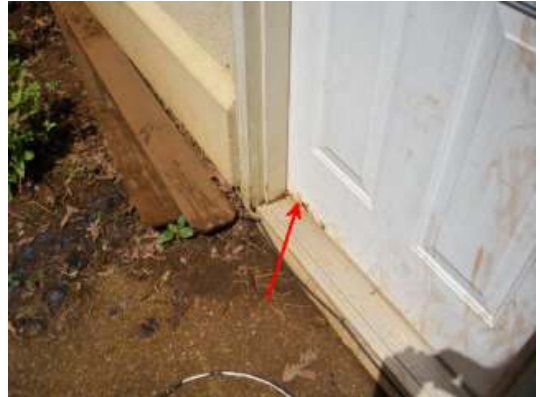
Door damage

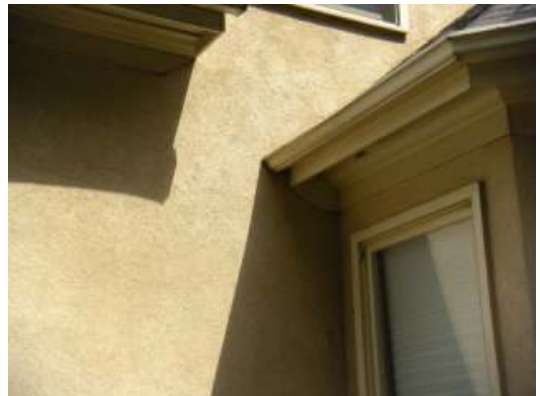
Normal readings below missing kick out

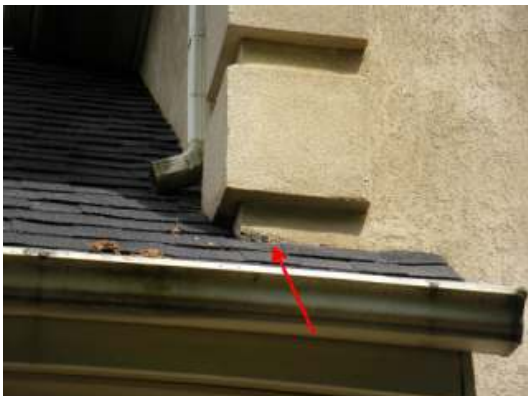
Needs extension flashing

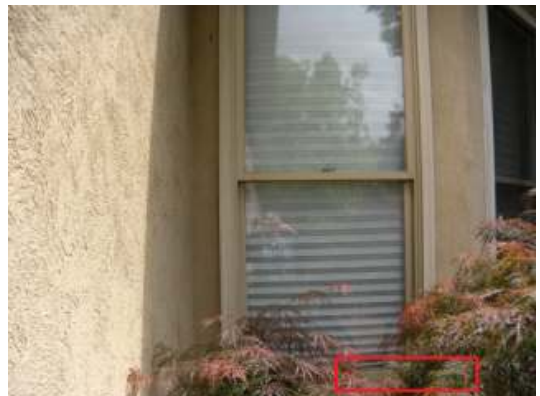
Damage below window

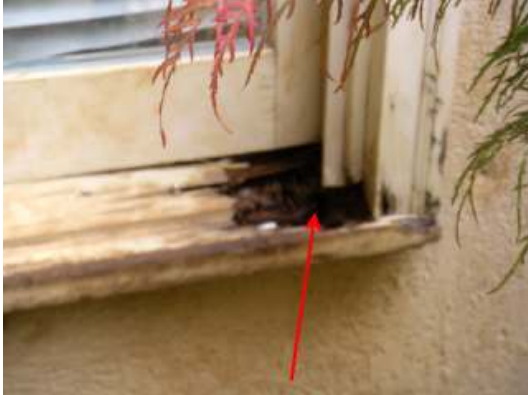
Rotten sill.

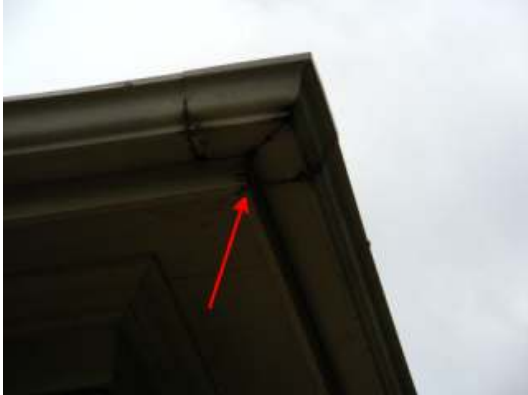
Fascia rotten

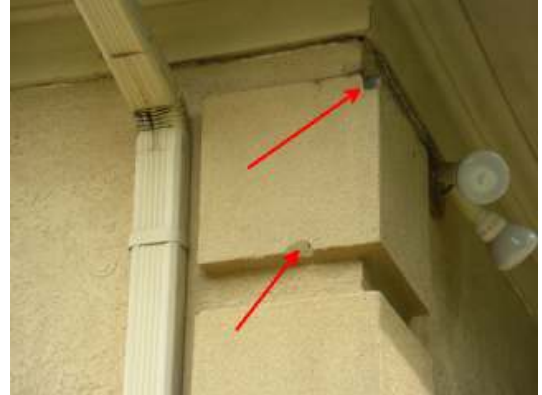
Damage to quoins

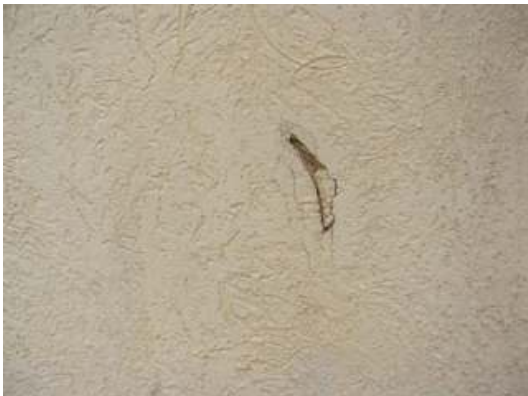
Impact damage

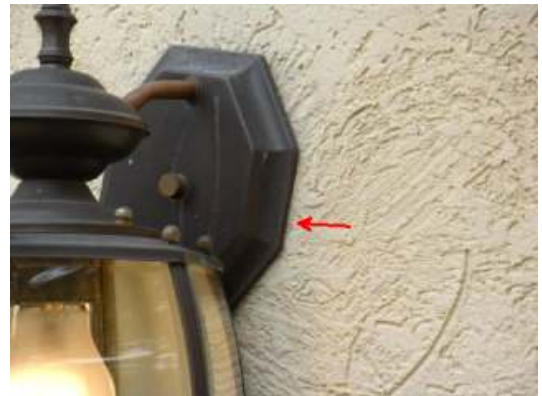
Missing caulk

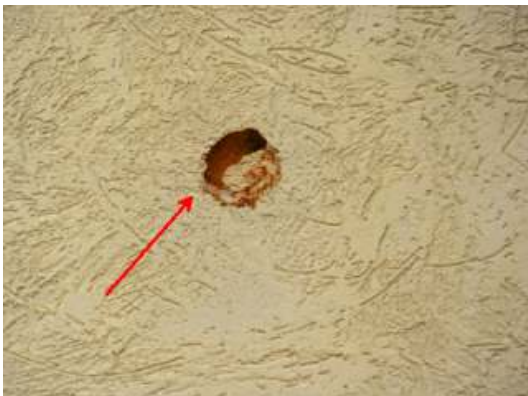
Bird hole
