Tennessee Building and Moisture Analysts

Stucco Inspection and Report

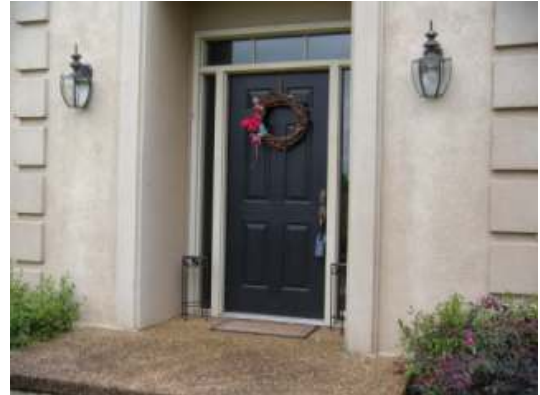
Normal

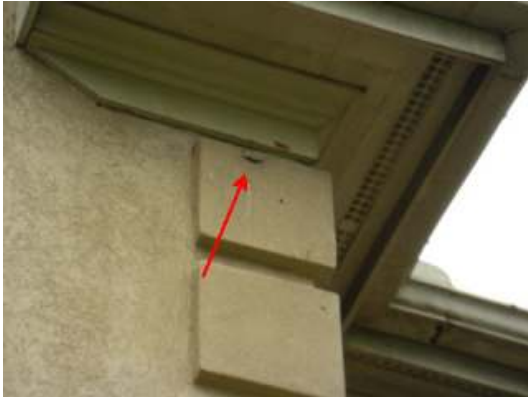
Bird hole

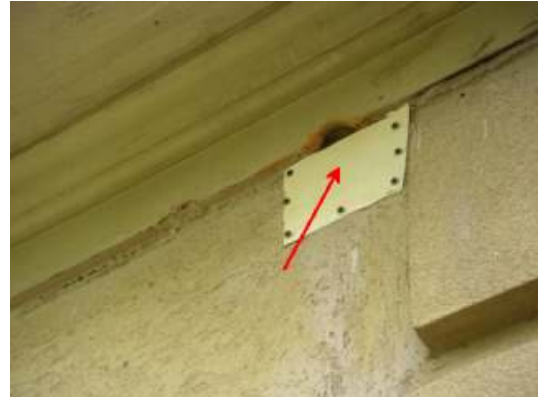
Squirrel hole

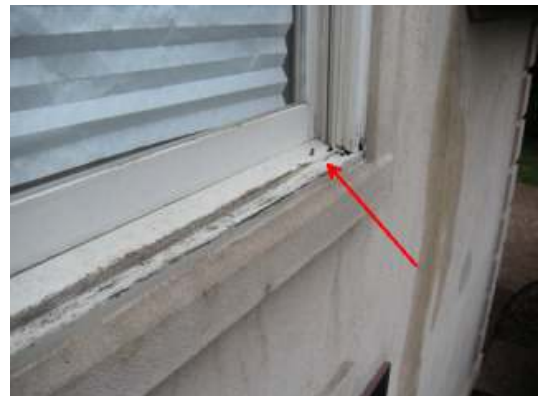
Rotten sill

There are several windows that have rotten sills and are leaking.

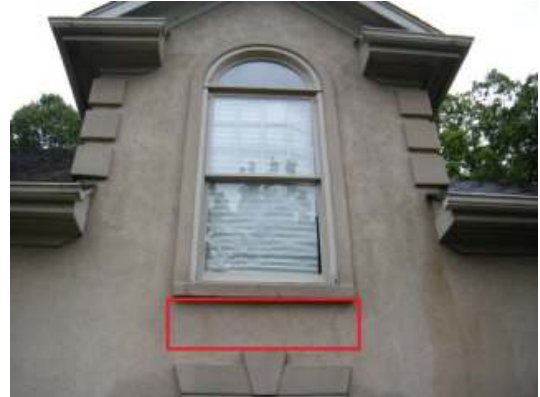
Elevated readings

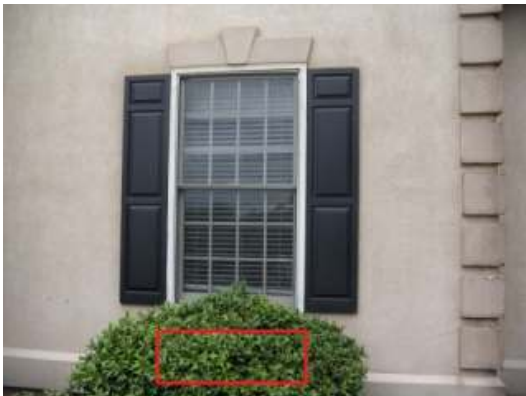
Elevated readings

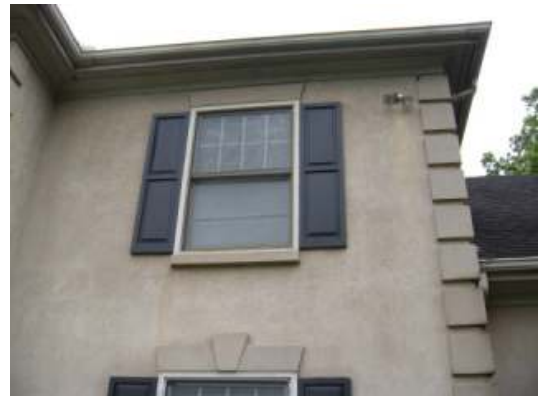
Normal readings

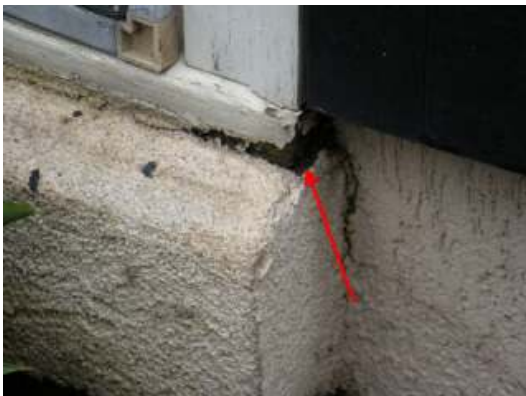
Soft wood

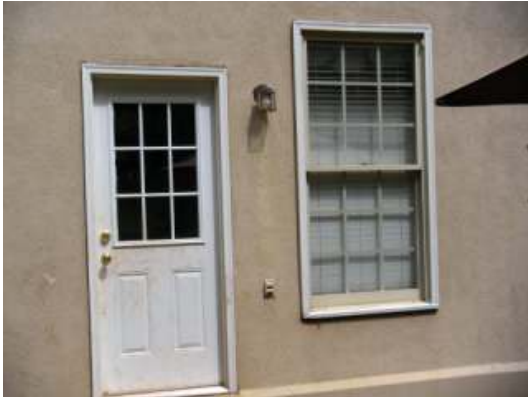
Normal readings

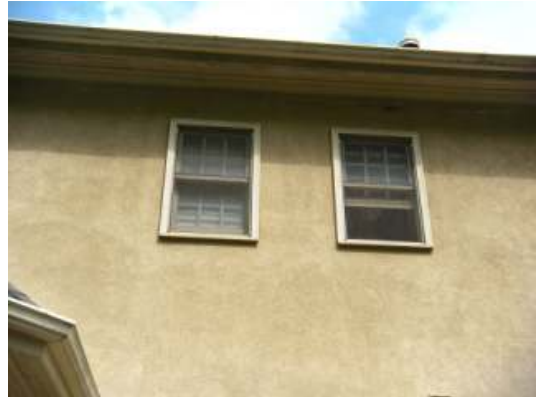
Normal readings

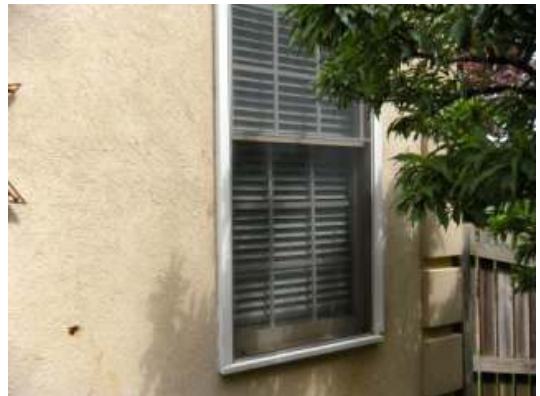
Normal readings

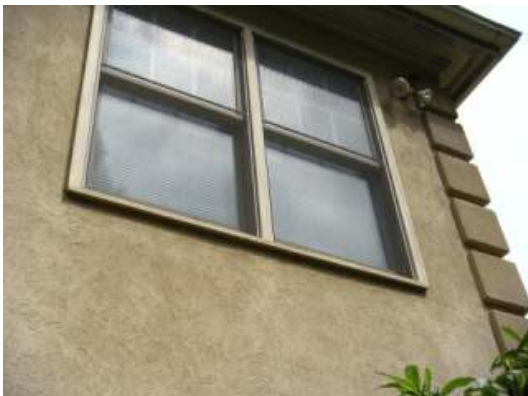
Normal readings

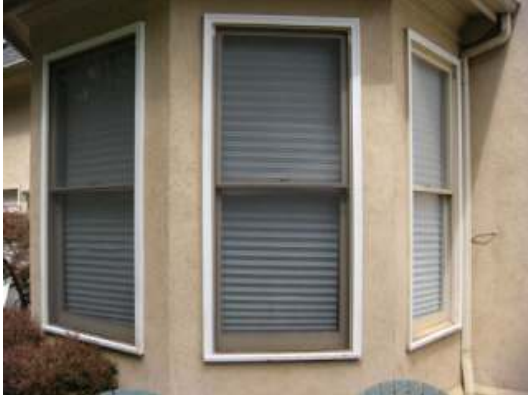
Normal readings

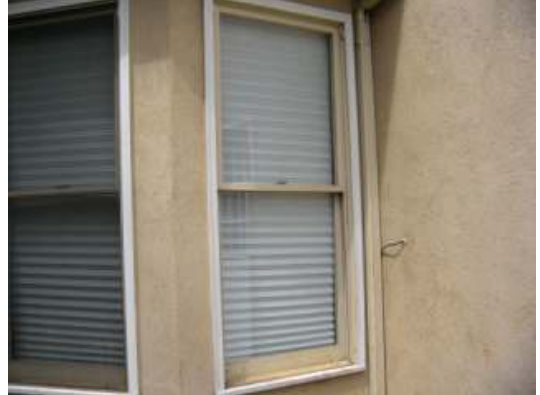
Normal readings

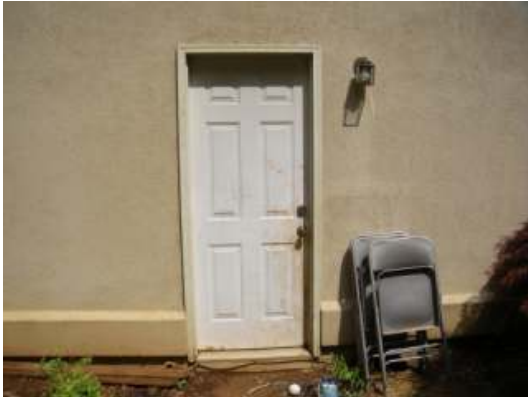
Normal readings

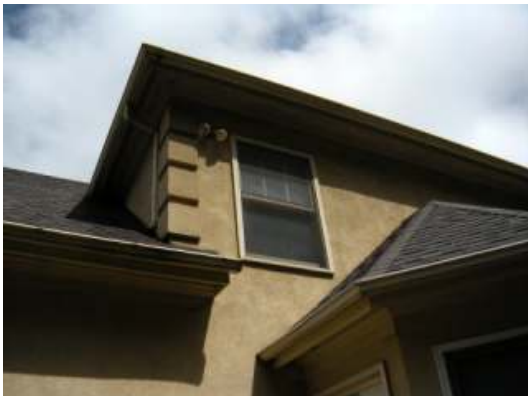
Normal readings

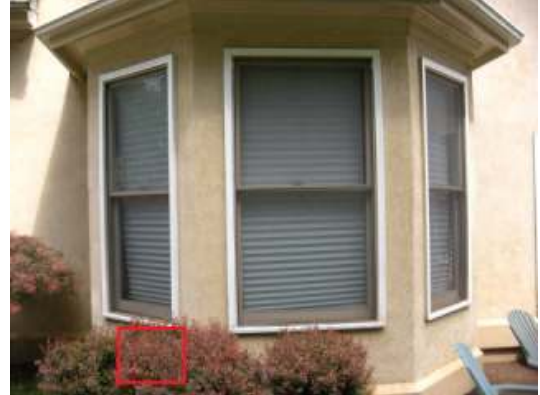
Elevated reading on left window

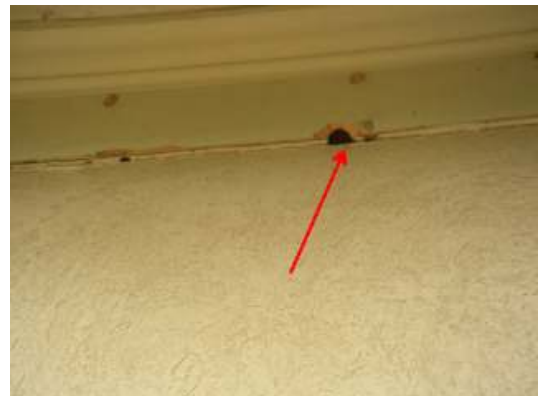
Squirrel hole

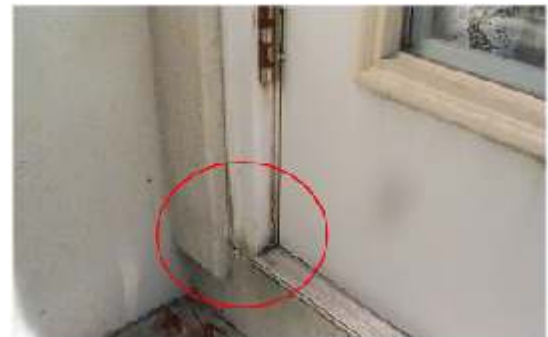
Fig. 1: Damage caused by No sealants

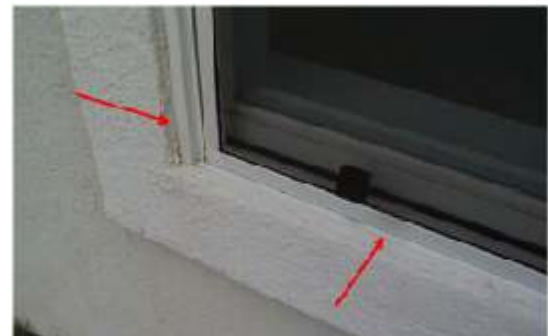
Fig. 2: Example of unsealed window perimeter

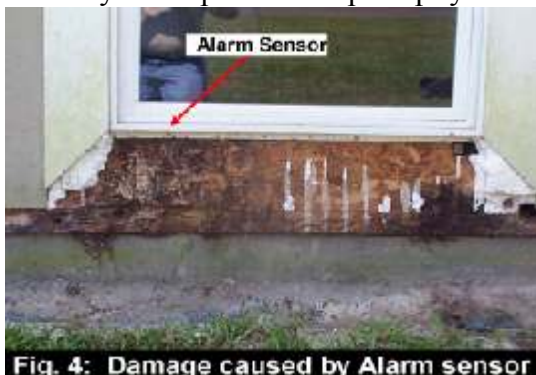
Fig. 4: Damage caused by Alarm sensor

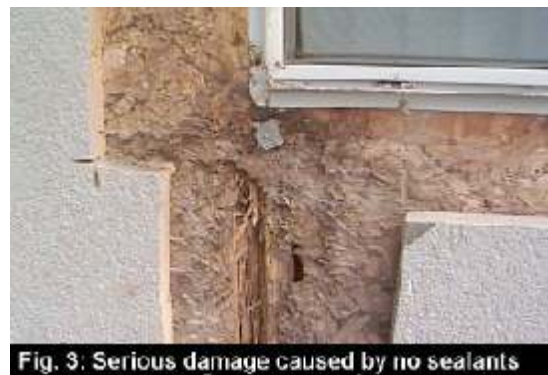
Fig. 3: Serious damage caused by no sealants

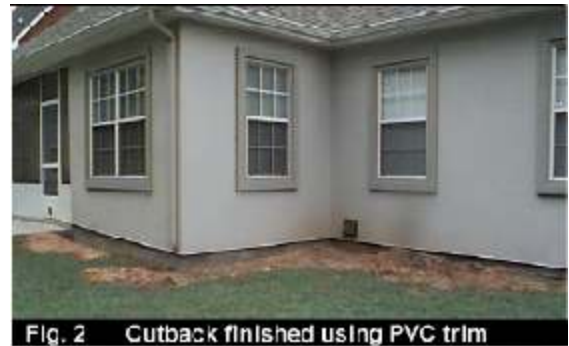
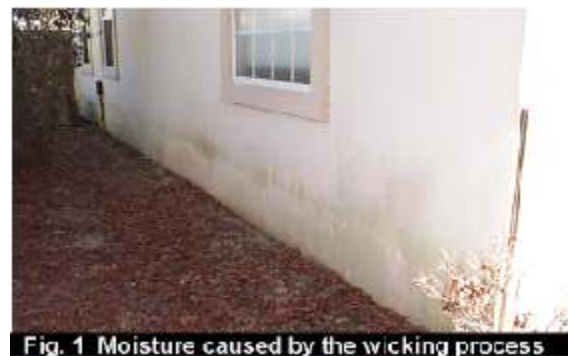
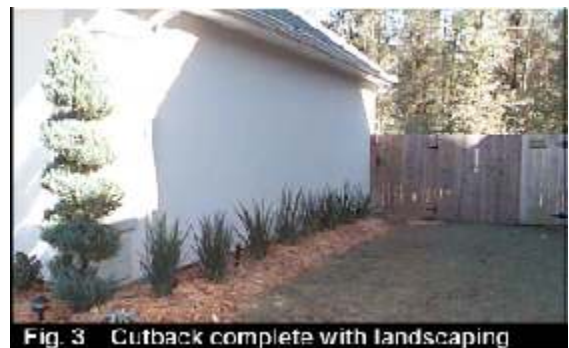
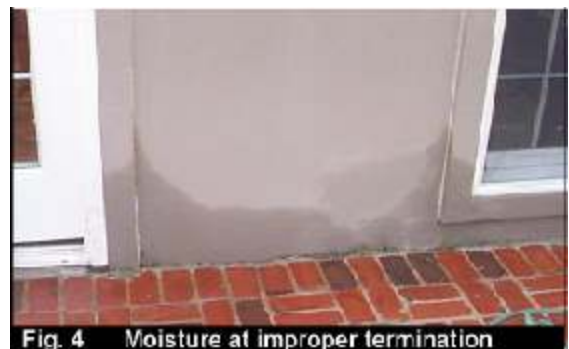
1) To prevent wicking, a process in which standing water is absorbed by the EPS foam board, which leads to mold and mildew behind EIFS. Figure 1 shows an example of a home where the stucco system was not backwrapped and extended below grade. Water wicked up behind the stucco, causing mold, mildew and decay of the underlying sheathing. Wicking can also occur when stucco is terminated at grade level as seen in Figure 4.

Termite problems associated with stucco systems that extended below grade were recognized in 1996 and various code bodies began to change code requirements. Because of the increased risk of termite infestation, many pest control companies won't issue termite warranties for buildings with below grade stucco terminations including 'hard coat' stucco systems in many cases. One way this problem can be resolved by cutting the stucco eight inches above grade and adding a PVC accessory trim to "lock" the EPS board in place (Figure 2). The PVC accessory trim is an optional item that looks nice and eliminates the need for backwrapping the EIFS. The trim is then sealed with a high-quality sealant. Finally, a textured coat is applied to the bare foundation wall and colored to match the existing EIFS. The pictures below show a cutback with accessory trim. Once landscaping is in place, the modification is hardly noticeable (Figure 3).

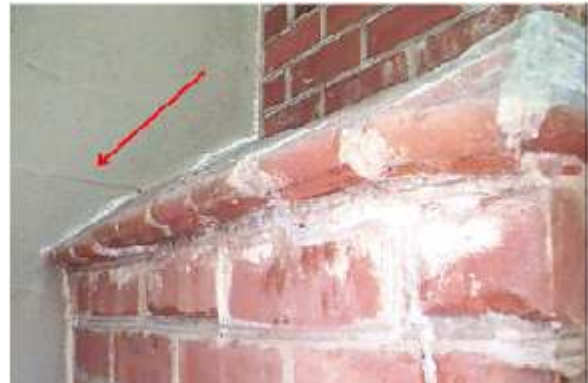
It does not take a very big crack to allow water intrusion. In fact, a crack as small as 1/16" of an inch wide can permit water to enter behind the stucco, especially with a stucco system that has no moisture barrier. All cracks 1/16" wide or larger and all damaged areas of stucco should be properly repaired as per manufacturers guidelines. Many times the patched areas will still be slightly noticeable even with a good repair application. Extreme cracking will sometimes require the reapplication of EIFS base, mesh, and finish to prevent more cracking and provide a consistent appearance. Cracking is common in hard coat stucco systems, therefore expansion joints are called for every 144 sf, as well as between floorlines and extending vertically from window and door corners to help control cracking. One reason EIFS is so popular, is that these expansion joints, which many feel are unsightly, are not usually necessary with EIFS. The exception to this is that they are needed between floorlines to compensate for the cross-grain shrinkage of wood. As seen in Figure 1, the lack of an expansion joint between floorlines will result in a compression crack in this area. Again, consult with manufacturer for specific requirements of expansion joints.

Fig. 1: Example of cracks at floorlines

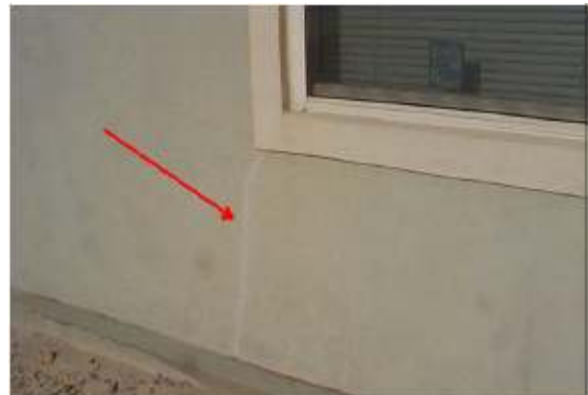
The most common areas that experience cracking in EIFS are at the corners of windows or roof terminations as seen in Figures 2 and 3. To prevent cracking in this area, most manufacturer and EIMA details specify that an additional layer of reinforcement mesh be applied diagonally at the corners of all windows, doors and other openings. This is called "butterfly" mesh.

Fig. 2: Example of crack at window corner

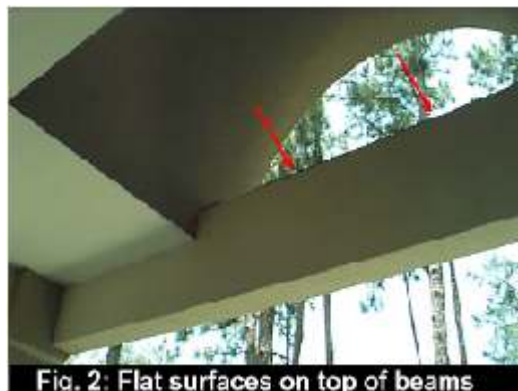
Flat stucco surfaces, whether conventional hard coat stucco or EIFS, collect and hold water in its rough texture, softening the finish coat, damaging the system and promoting leaks, mildew and discoloration. A good EIFS design will call for bands, quoins, and other accents to have a slope to prevent water accumulation.

Fig. 2: Flat surfaces on top of beams

The easiest corrective measure would be to coat all flat surfaces with an elastomeric waterproofing coating tinted to match the existing stucco color as closely as possible. Large flat areas, such as a parapet wall, can be capped with metal and sealed.

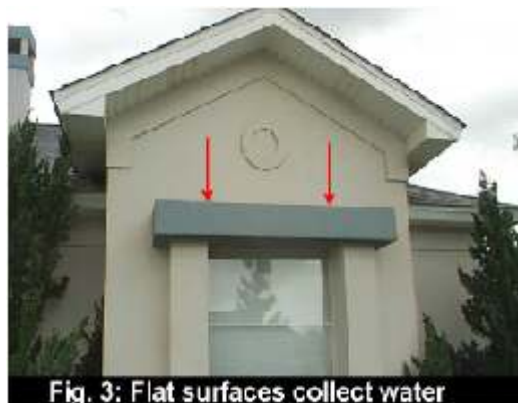
Fig. 3: Flat surfaces collect water

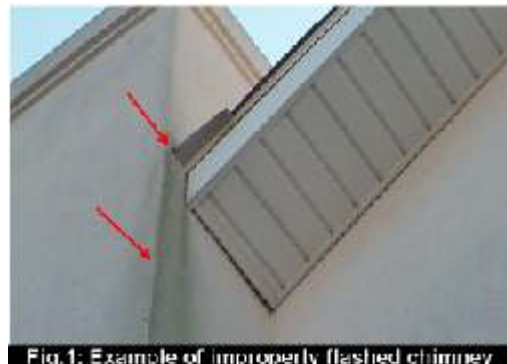
Fig.1: Example of improperly flashed chimney

Figure 1 shows a chimney that was not properly flashed (sidewall and kickout flashing see section 3.4) which resulted in wood rot and termite infestation. Figure 2 shows a chimney coping that was not sealed to the stucco which has now separated and will allow water into the chimney chase.

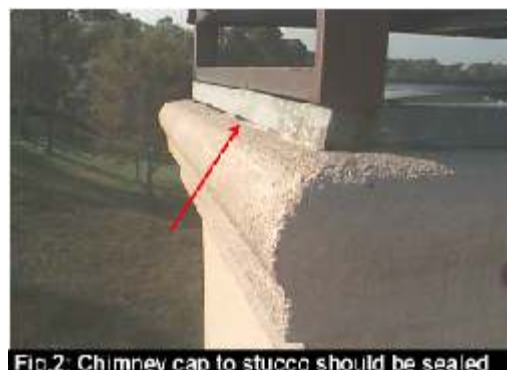
Fig.2: Chimney cap to stucco should be sealed

A properly designed chimney cap (coping) will shed water away from the stucco to metal joint (Figure 2) and help prevent leaks in this area. The flue should be properly sealed to the "storm flashing" and the chimney cap (coping) sealed to the stucco.

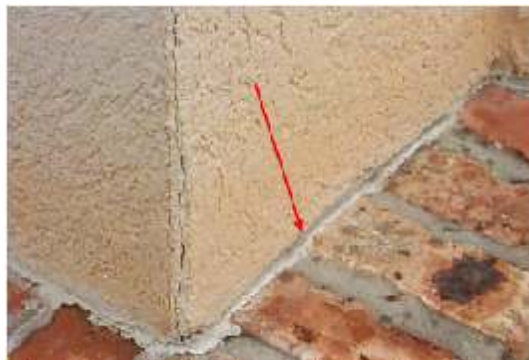
Different materials expand and contract at different rates. This expansion and contraction causes a crack or gap to form where the two materials join.

Fig 1: Stucco to brick transition needs sealing

If left unsealed, or if sealed improperly, this area will allow water to enter the wall cavity. Examples of this would include stucco to wood trim, stucco to brick (Figure 1), stucco to stone (see Figure 2), stucco to concrete, etc. All areas such as these should be sealed with quality sealants and appropriate bond breakers.

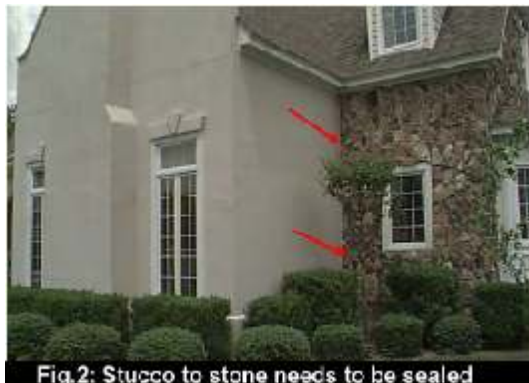
Fig.2: Stucco to stone needs to be sealed
